Schuilplaats Road Extension Environmental Monthly Summary Report No. 2 - July 2020

Score	88.61%	Failed items	1	Actions	0
Project/Site	Schuilplaats Road Extension				
Location	Stellenbosch, Western Cape.				
Project Personnel	Project Manager - Petri Germishuys Martin & East - Martin Maree Martin & East Site Agent - Ryno Maritz Martin & East DEO - Mawethu Mtshafuto Ecosense ECO - Vincent Masefield				
Audit Document Number	Schuilplaats Road Extension Environmental Monthly Summary Report No. 2 - July 2020				
Report Date	4th Aug, 2020				
Prepared By	Vincent Masefield

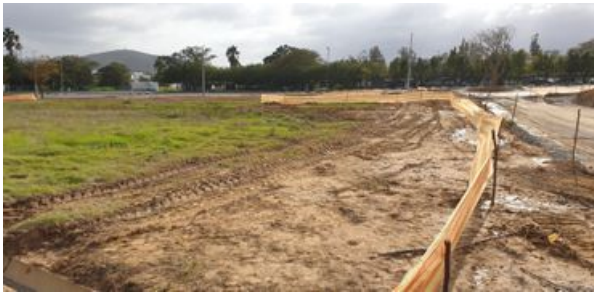
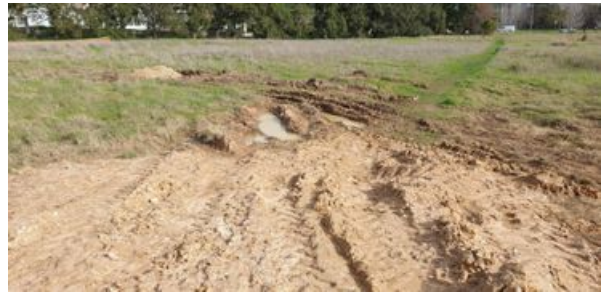
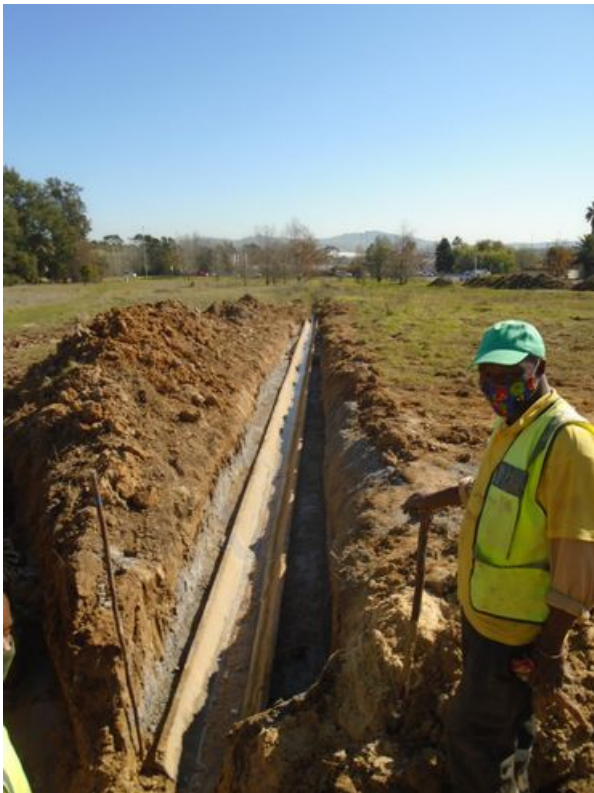
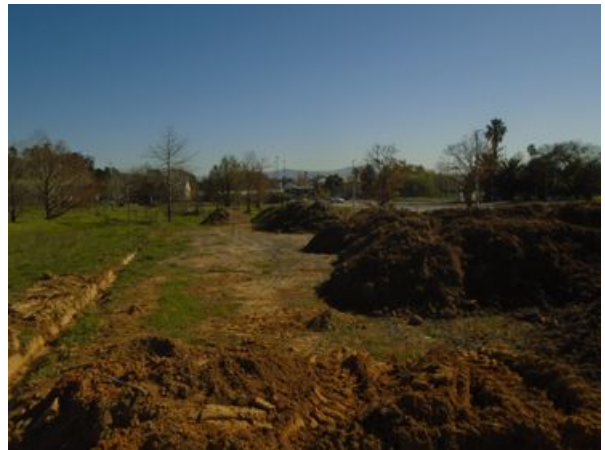
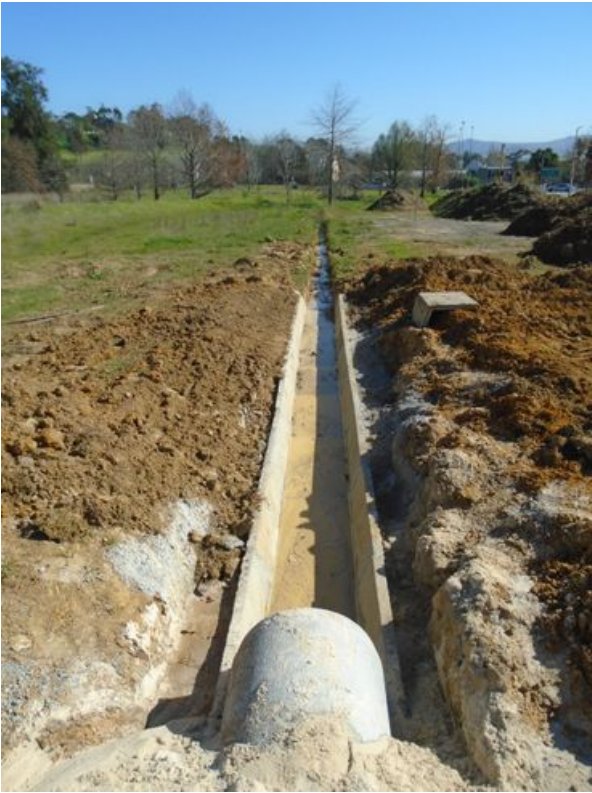
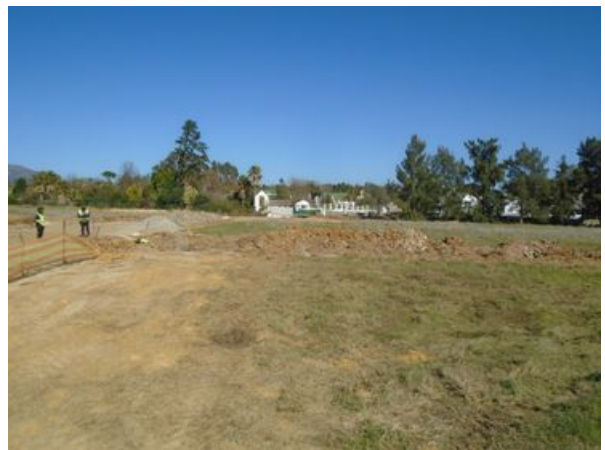
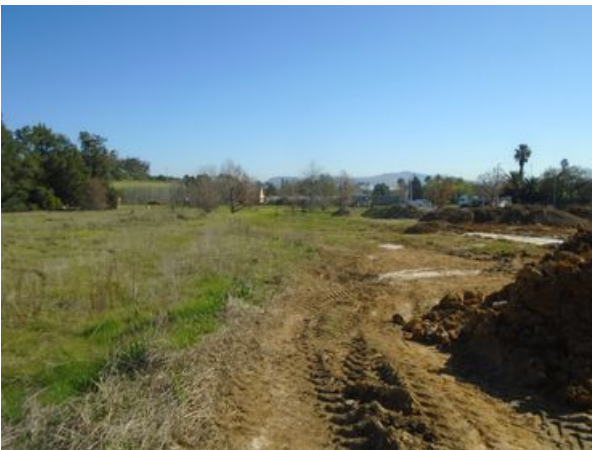
2.1. Are the site/work boundaries and no-go areas adequately demarcated/fenced/hoarded?

Partial Compliance

Disturbance of ground outside of the work boundaries by a vehicle/plant was observed. Contractor to ensure that project personnel remain within the work boundaries and that the disturbed ground is reinstated (09/07/2020). The site boundaries must be delineated where works on the stormwater channels is taking place and all stockpile areas must be adequately demarcated (23/07/2020).

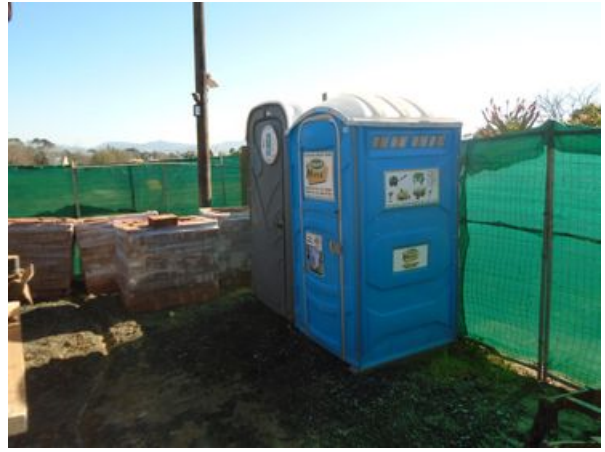
Photo 8

2.5. Are there sufficient, clean and secured toilets available for employees on site?

Compliant

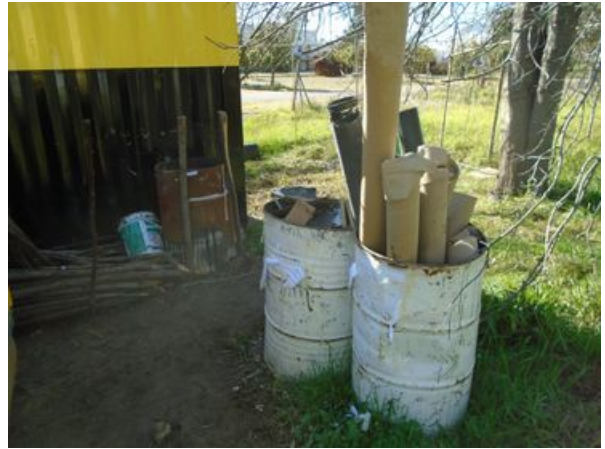
Photo 10

3.2. Are wastes being adequately separated into appropriate waste streams and recycled (i.e. scrap metals, plastics, card boards, clean rubble, etc.)?

Compliant

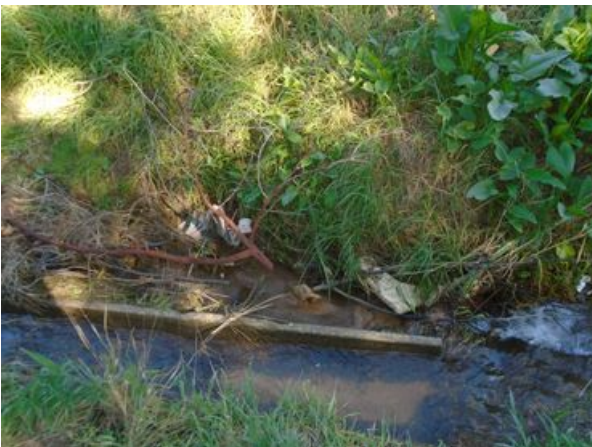
Photo 9

3.1. Was proper solid waste management/housekeeping observed on site (i.e. in accordance with the waste management plan; all construction areas kept in a neat and tidy condition; daily litter pick up evident; covered and sufficient waste disposal facilities in place and at approved locations, etc.)?

Partial Compliance

At the time of the site inspection on the 23rd of July 2020, one or two pieces of waste was observed downstream from the watercourse works area which required removal. The Contractor subsequently closed out this issue.

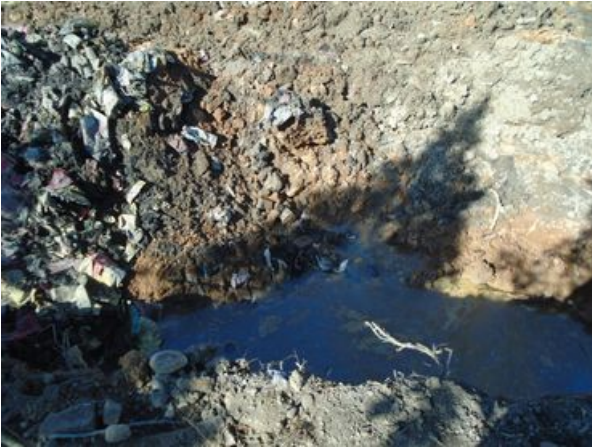
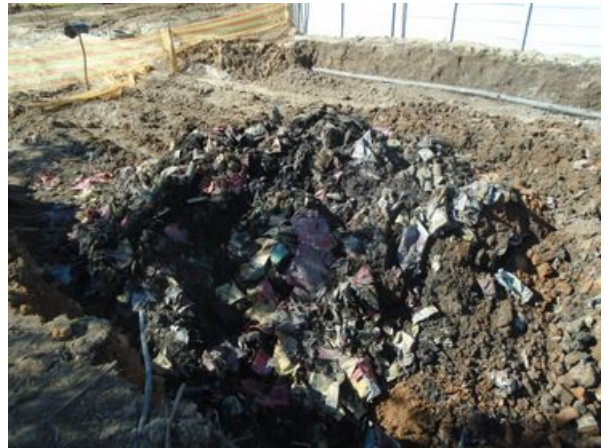
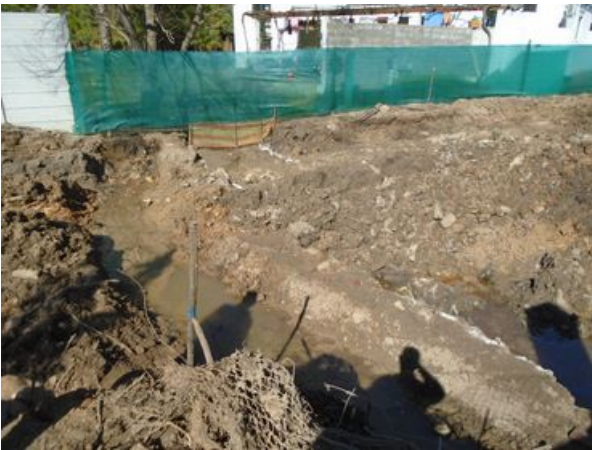
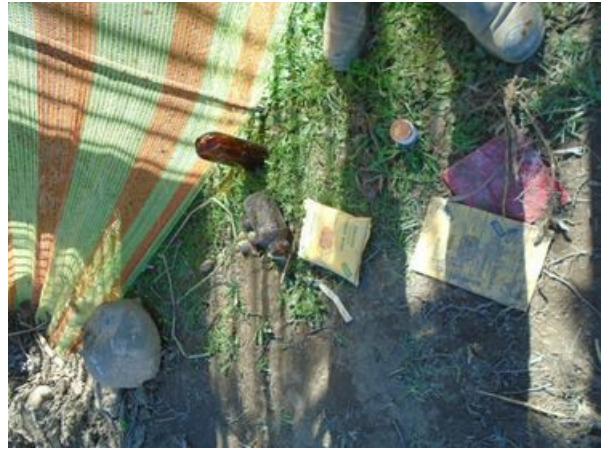
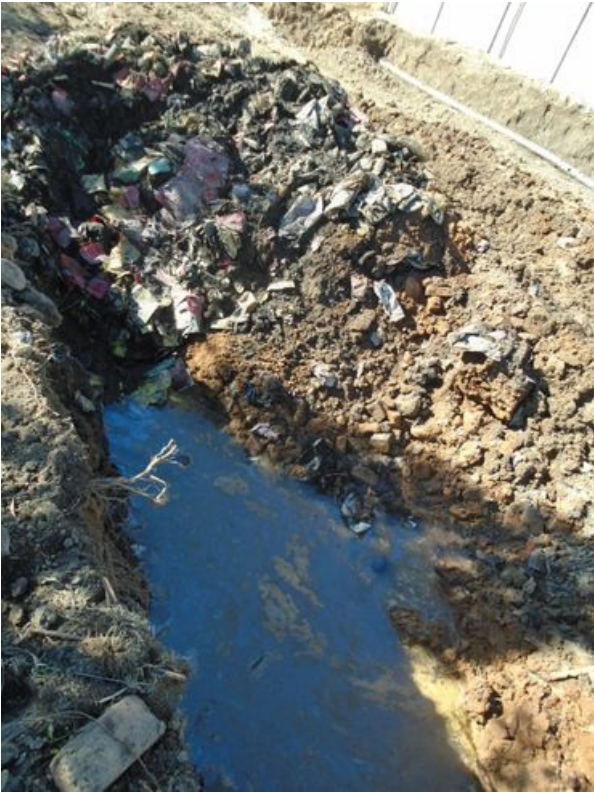
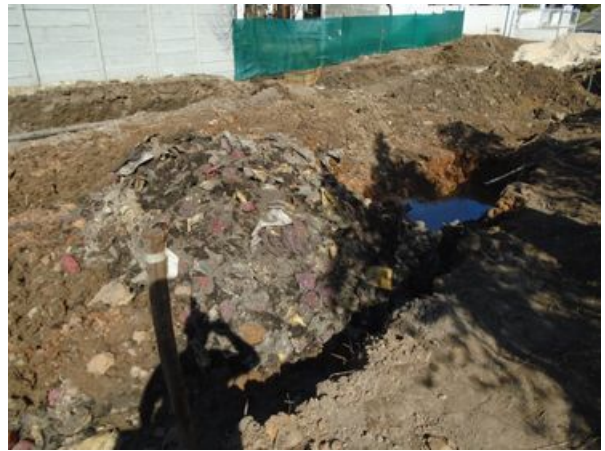
3.3. Is proper hazardous waste management been observed on site (i.e. appropriately separated, handled, stored in separate labeled, covered and appropriately located disposal facility prior to disposal off site)?

Partial Compliance

Toxic waste was uncovered on site when excavating for foundation work of the road to be constructed through the wetland area on site. The ECO was not notified of this uncovering when it happened and discovered this concern during a site inspection. Project Management/Contractor must notify the ECO of such occurrences immediately! Subsequent to the uncovering of this waste, the local municipality was called to assess the waste and a report was produced (attached to this report). Further, waste removal companies Averda and Wastemart have been contacted to assess the toxic waste and provide recommendations to address this issue. An action plan method statement is required from the Contractor/H&S Officer detailing way forward and remedial actions to be undertaken to not only dispose of the waste, but also treat contaminated soils and water at this location. All works in this area have been stopped until a way forward is determined.

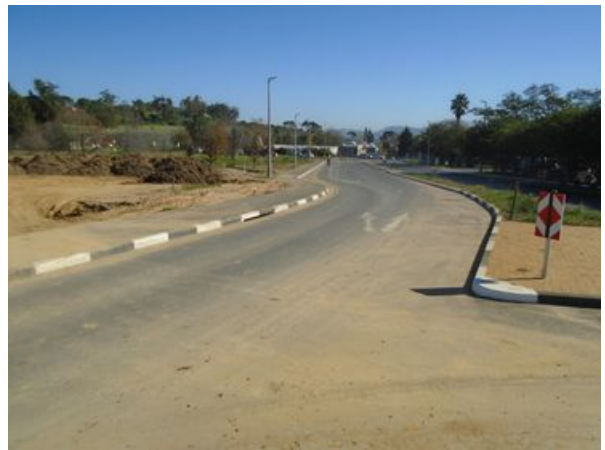
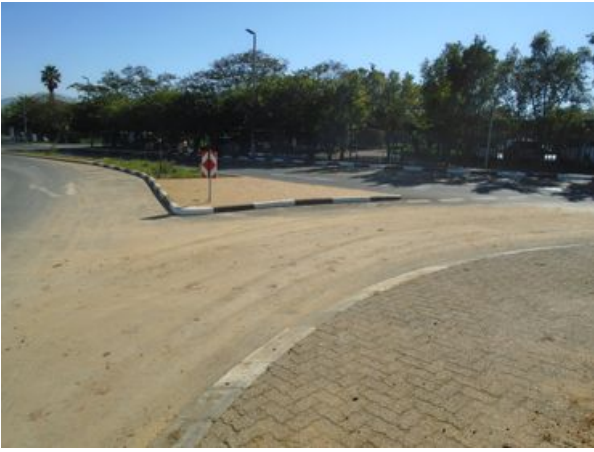
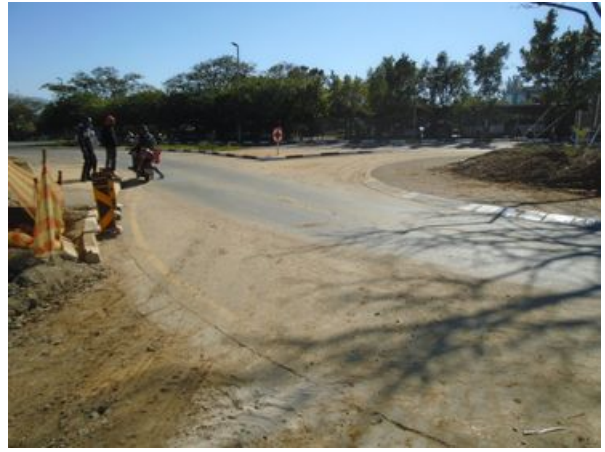
4.9. Were internal and external roads observed in a clean and sediment free condition?

Partial Compliance

The public road bordering the site must be cleaned of all sediment and maintained in a sediment free condition at all times (23/07/2020). This issue has been subsequently addressed by the Contractor.

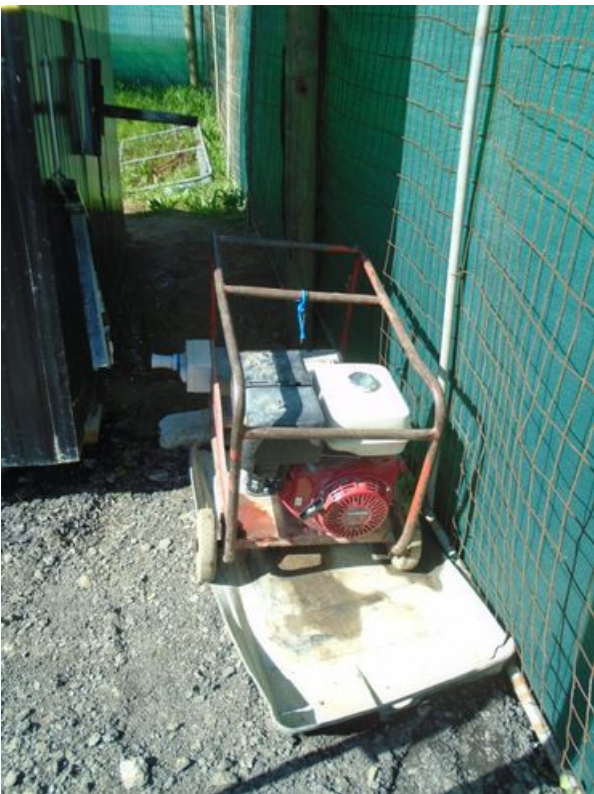
Photo 17

4.3. Are drip trays being used where required on site (i.e. generators, stationary vehicles, refueling, contaminated equipment, etc.)?

Partial Compliance

Great to see the Contractor using drip trays, however, the drainage holes in these trays must be closed/sealed (23/07/2020).
