MEMORANDUM

On 21st July site visit was conducted by the Solid Waste Management at Roads, Transport and Stormwater (Schuilplaats Road Project) site, with the primary focus being on identifying types of waste that was discovered at the site. Different chemical waste streams including nitrogen bacteria, rusted chemical containers, and bottles of chemicals were noted to be illegal dispose of (buried underground).

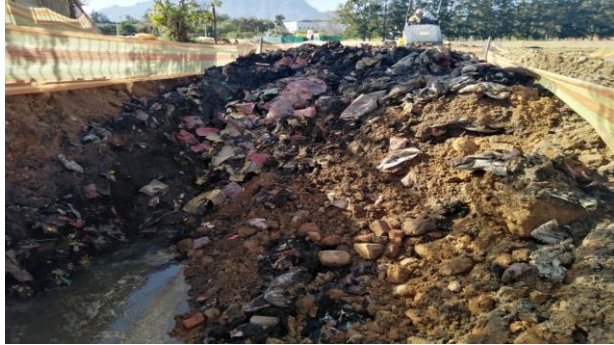
Photo 1: Mixed waste observed at the site.

According to ISO 14001, OHSAS 18001 and Occupational Health and Safety Act 85 of 1993 , we need to ensure that we protect our people as well as the environment. Likewise, collection, transportation and disposal of hazardous waste legal requirements must be followed. Having said that, urgent clean-up is required at the site and the surroundings thereof. Chemical waste to be collected and be disposed of by the accredited waste service provider.

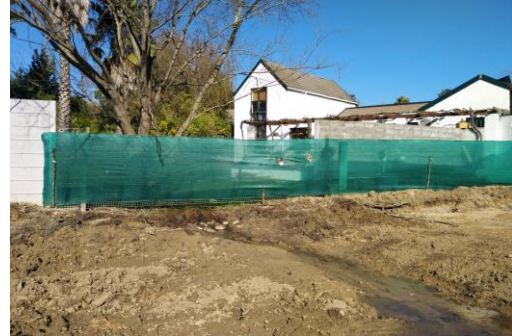
Some of the waste chemicals are unknown as the labels are faded and covered with mud. There is also a flowing stream at the site, groundwater sampling should be conducted to test the water quality and determine groundwater contamination. It was suggested that the contractor must dig up all the chemical waste so that we can be able to measure the waste quantity and make arrangements for disposal of hazardous waste to Vissershok. Relevant site photographs are presented at the end of this report.

Photo 2: Stream flow.

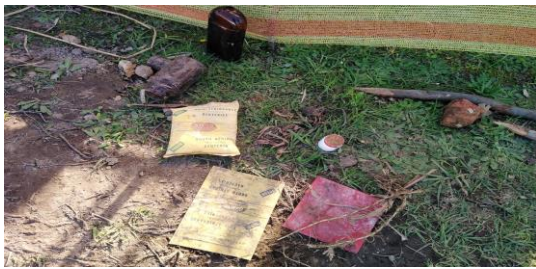
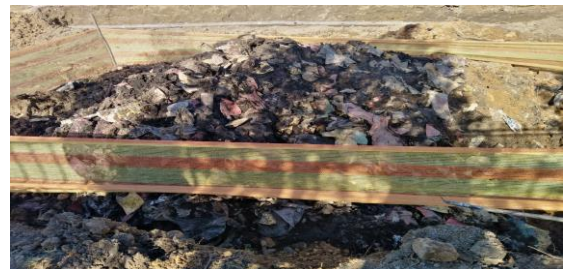
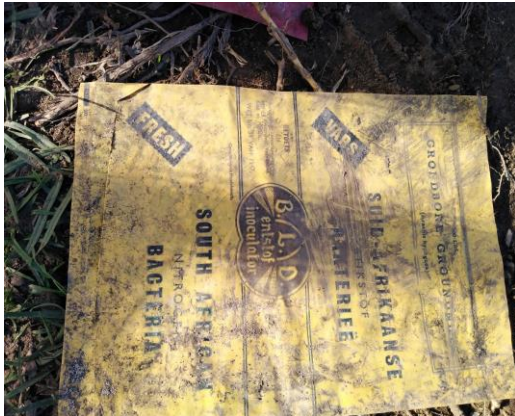
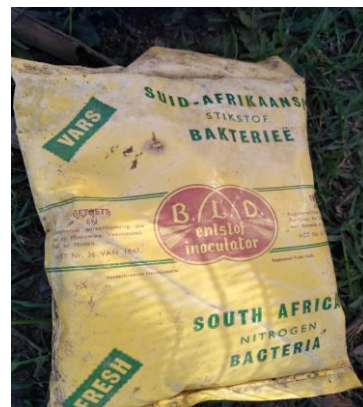
Photo 3: Nitrogen bacteria incorrectly disposed of.
